# **Effects of Slab-Column Interaction in Steel Moment Resisting Frames with Steel- Concrete Composite Floor Slabs**

A thesis submitted in partial fulfillment of the  
requirements for the Degree of  
Masters in Civil Engineering

by  
**Michael Hobbs**

Department of Civil and Natural Resources Engineering  
University of Canterbury  
Christchurch, New Zealand

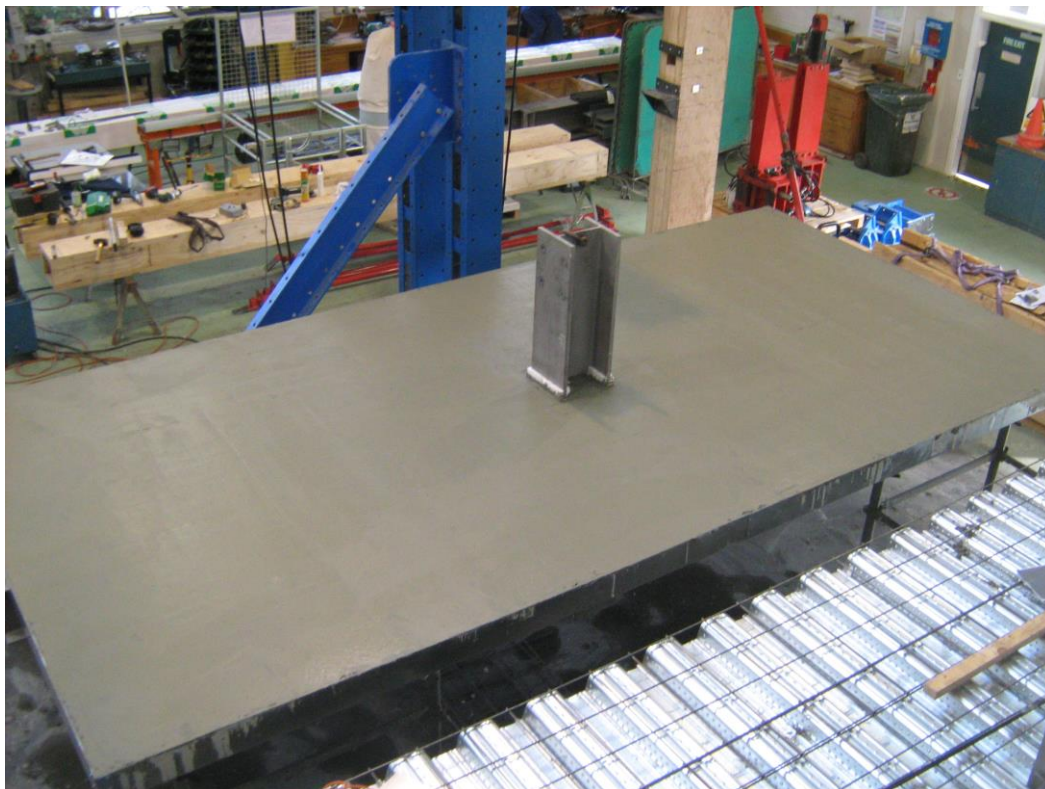
**Figure 3-13: Finished concrete slab before curing compound was applied.**

The slabs were each poured in one cast and the concrete was vibrated and screeded to the top of the edge trim as illustrated in Figure 3-13. A 4m screed was used to set the level of the slab to the top of the edge trim however hand screeding was required around the column. Final finishing was done with a bull float two to three hours after the initial screed.

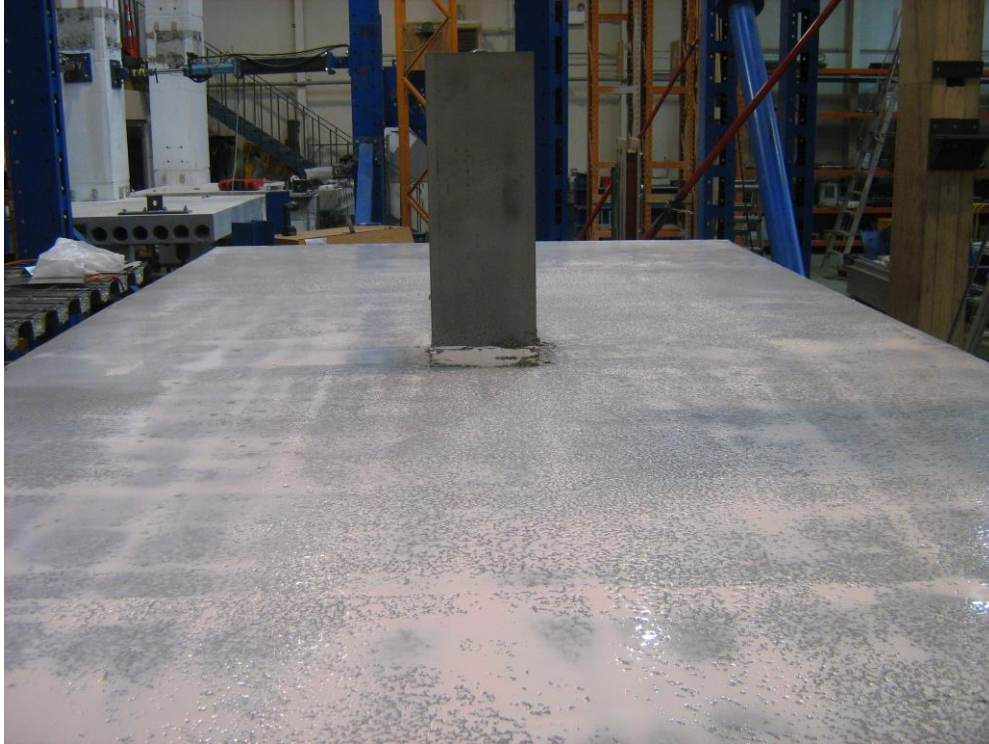
**Figure 3-14: Finished slab after curing compound was applied.**

To reduce the risk of shrinkage cracking due to excessive bleed Sika Antisol E, a wax based curing compound, was sprayed over the slab once the final finishing had been completed as shown in Figure 3-14.

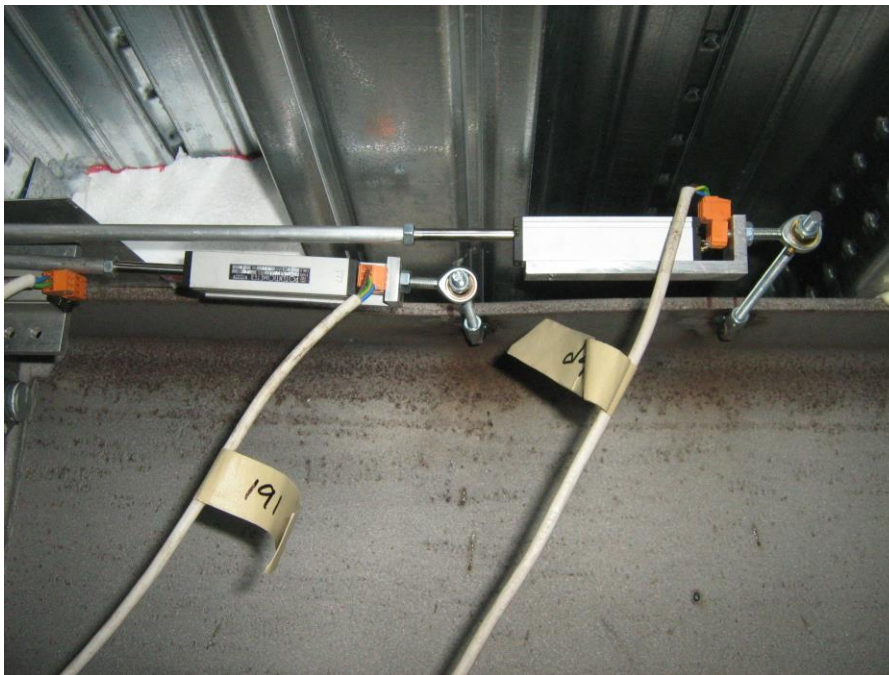
**Figure 6-2: Residual buckling in the top flange of the west beam, isolated subassembly after the 5% drift cycles.**

The top flanges did buckle but to a much lesser extent with a maximum of 14mm of residual buckle observed as shown in Figure 6-2.

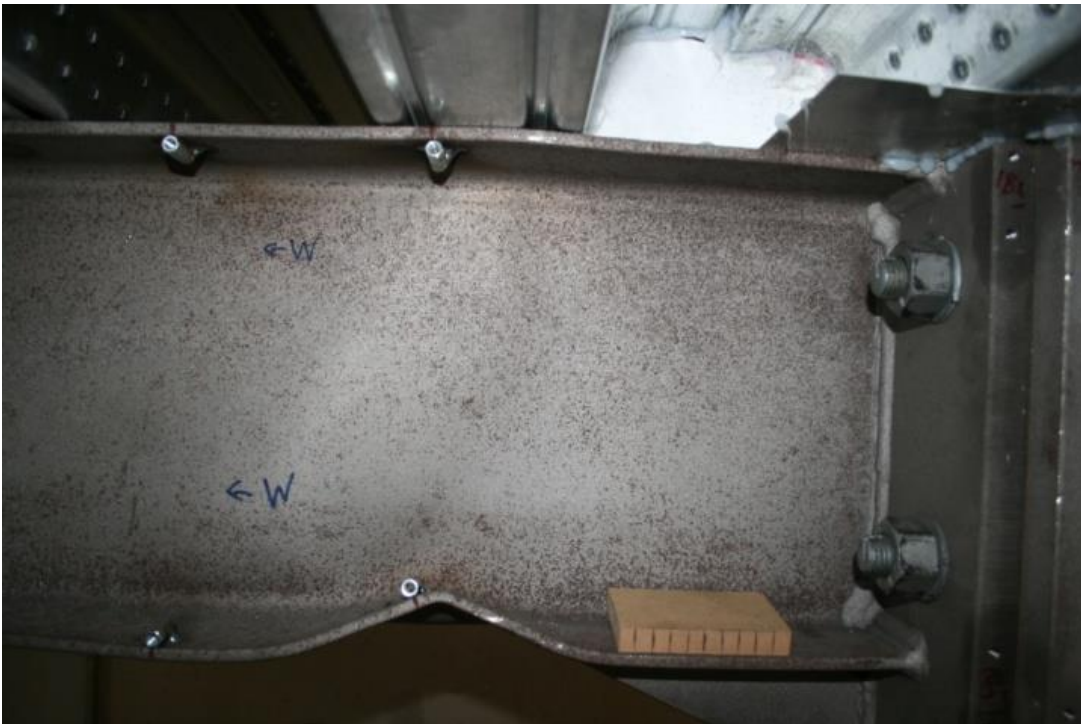
**Figure 6-5: Residual buckling in the top and bottom flanges of the west beam, transverse subassembly after testing to 5% drift.**

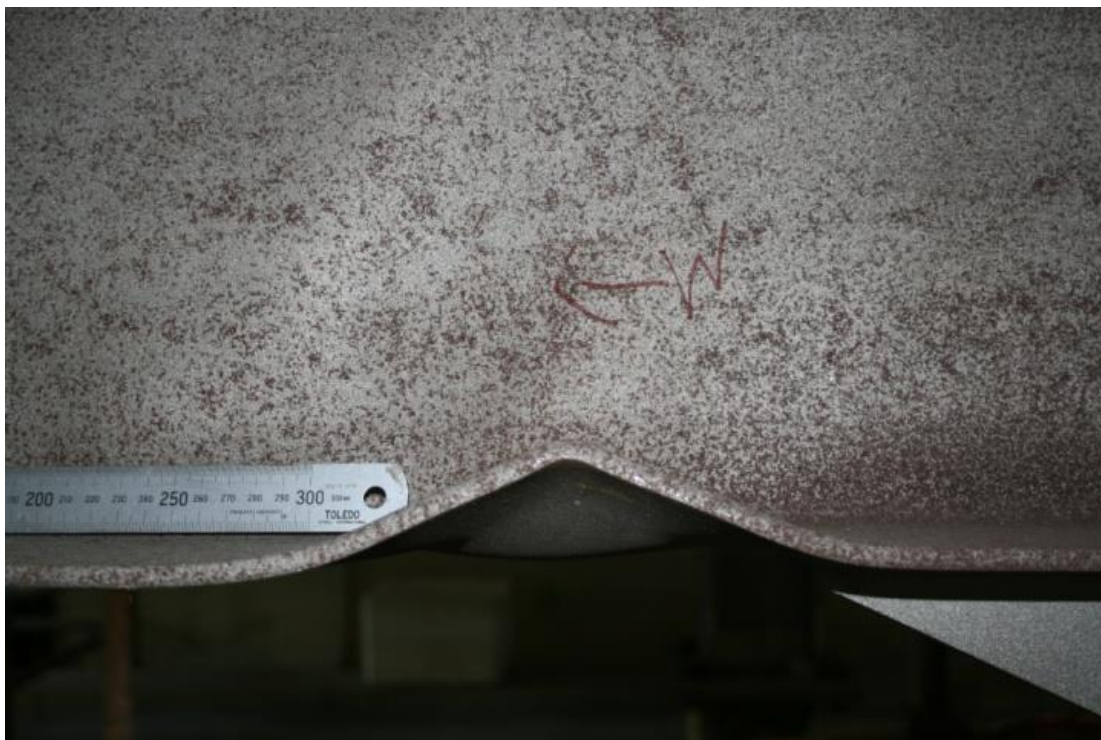
**Figure 6-8: Residual buckling in the bottom flange of the west beam, longitudinal subassembly after testing to 5% drift.**

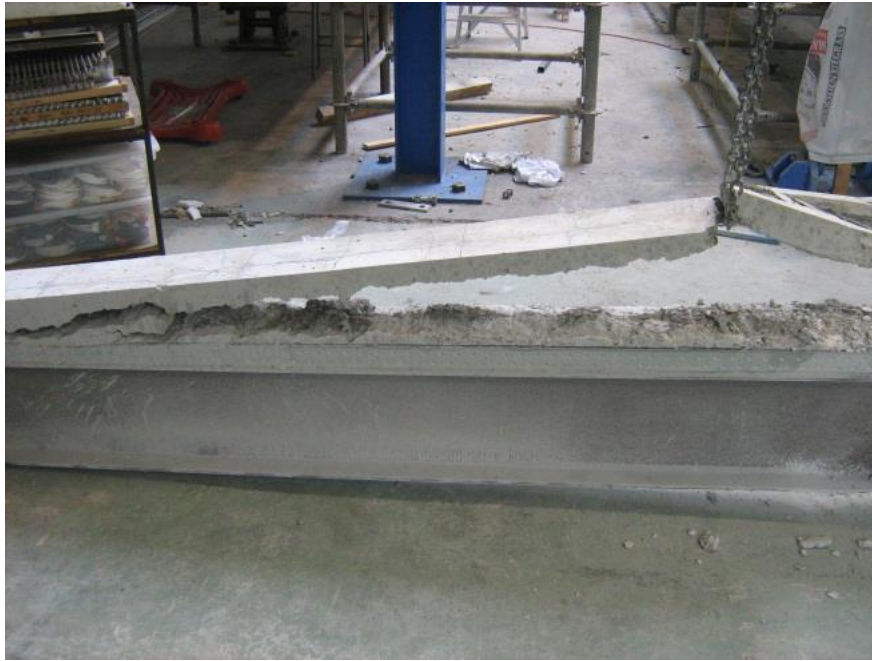
**Figure 6-11: Slab surface delamination along primary beam in longitudinal subassembly after testing.**

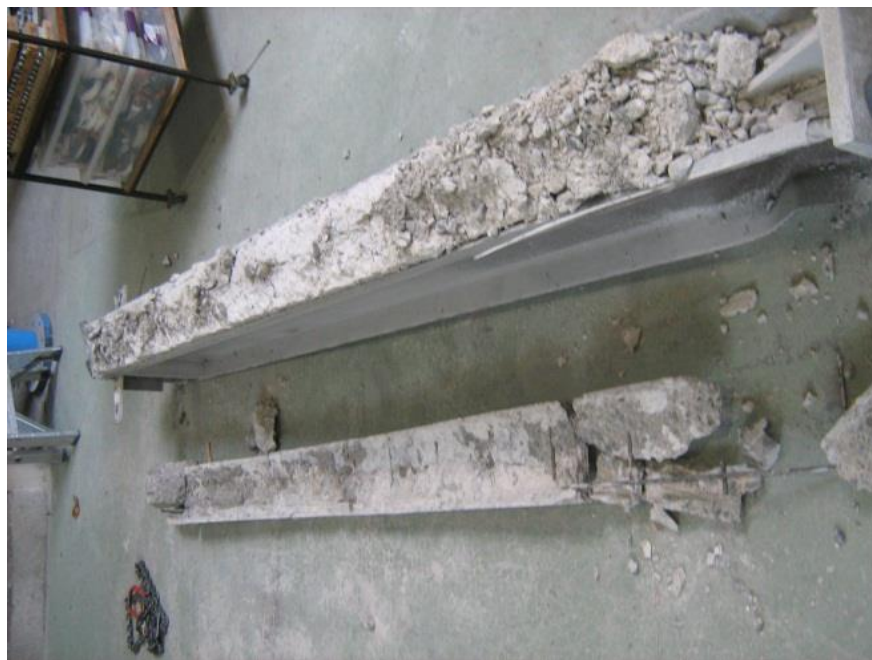
**Figure 6-12: Slab surface delamination along primary beam in longitudinal subassembly after testing.**

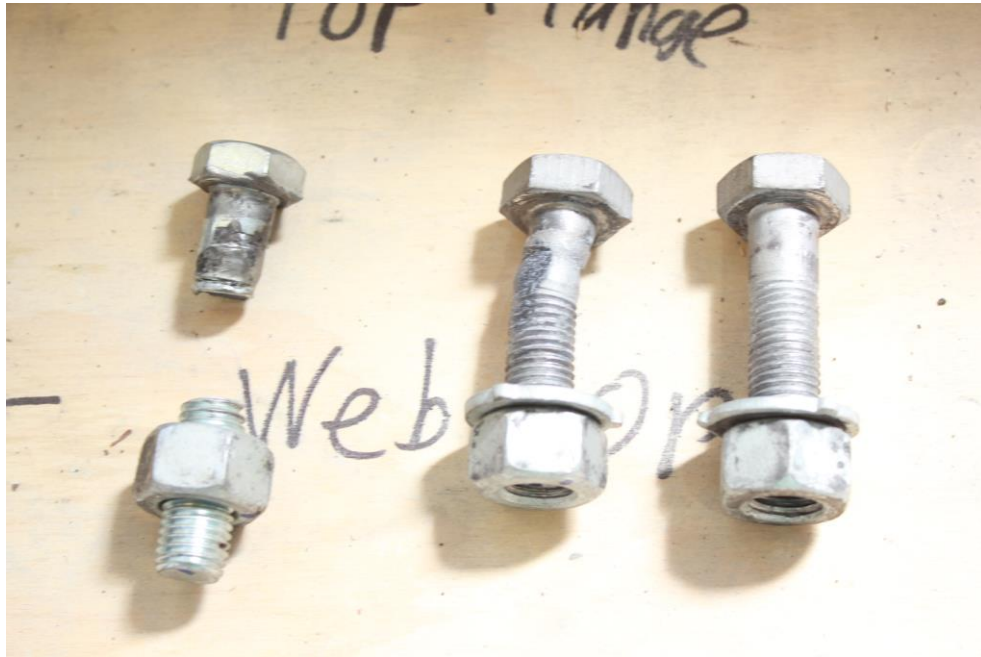
**Figure 6-19: Bending and shearing of one row of bottom flange bolts, SHJ subassembly.**
